Consolidation Coal Emery Mine Subsidence Report for July 2008

7-16-08

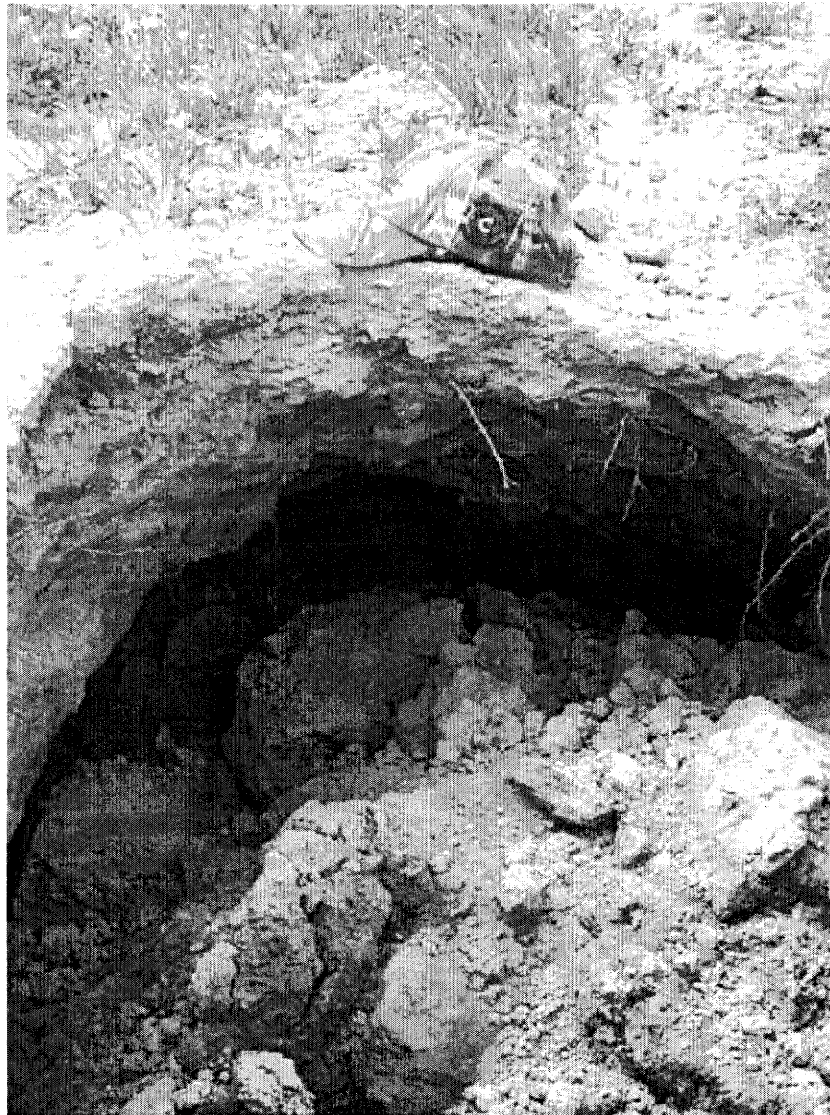
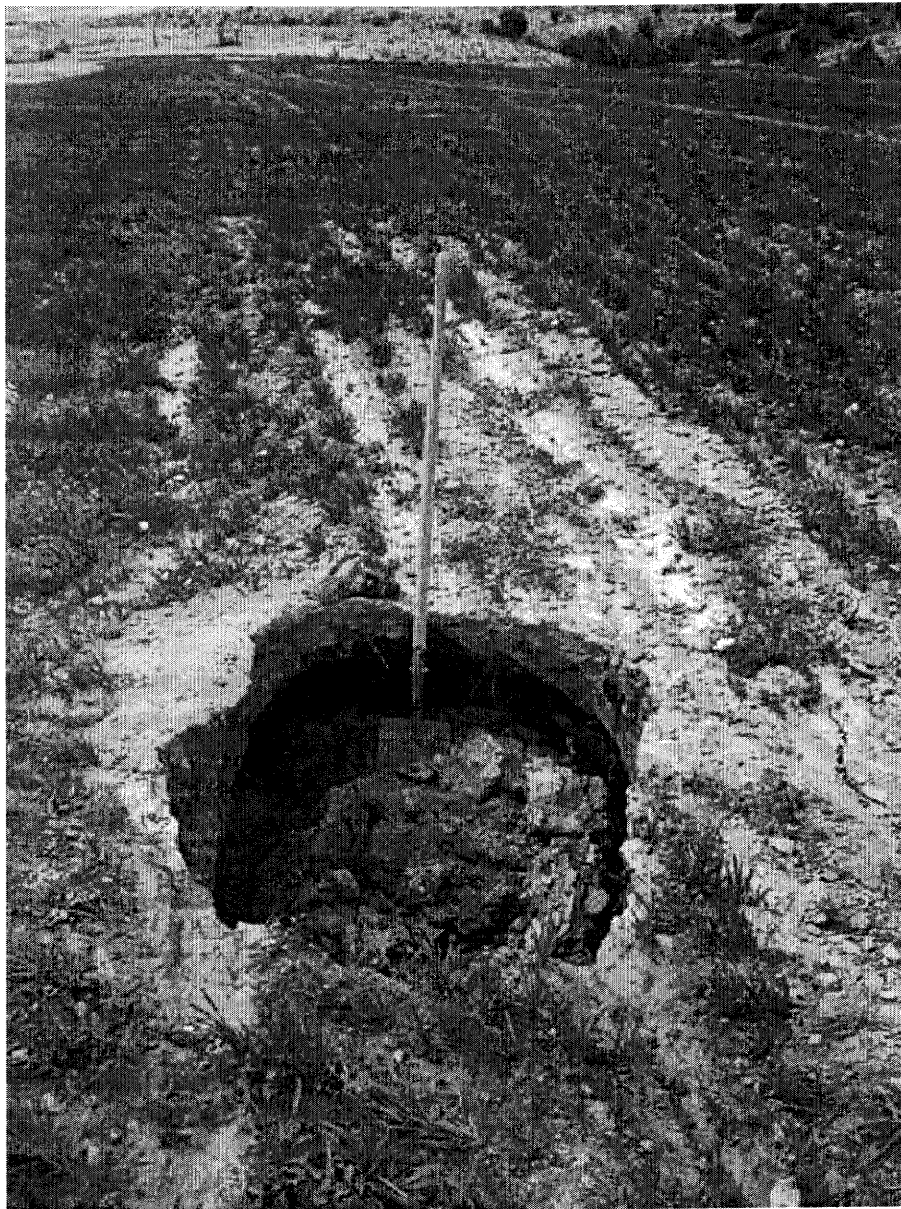
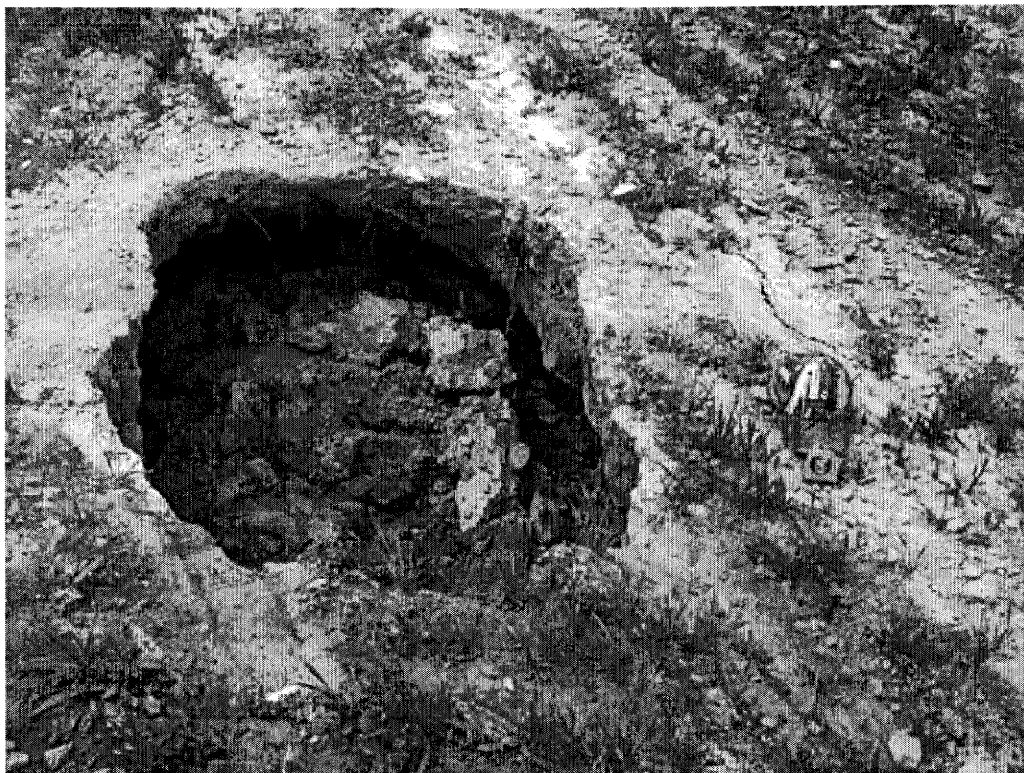
Panel 14 West – Mr. Carter, the landowner above panel 14 and 15 West, notified the mine that he had found some new sinkholes while working his farm. Three holes were found and pictures of the largest hole (Sinkhole #1) are shown below. This hole measured 3 ½ feet by 4 ½ feet by 3 feet deep. The next sinkhole identified (Sinkhole #2) was half the size of Sinkhole #1 and was located near the same area. The final hole (Sinkhole #3) was located near a previous hole and the measurements were 1 foot by 1 foot by ¾ foot deep. The last photo shows Sinkhole #3. PB
